# PROPERTY & BUILDING CONDITION REPORT

Association common areas, amenity buildings and grounds · property condition record · capture date withheld

| <b>Property</b> | Address withheld | <b>Report ID</b> | MWA-SMP-0006 |

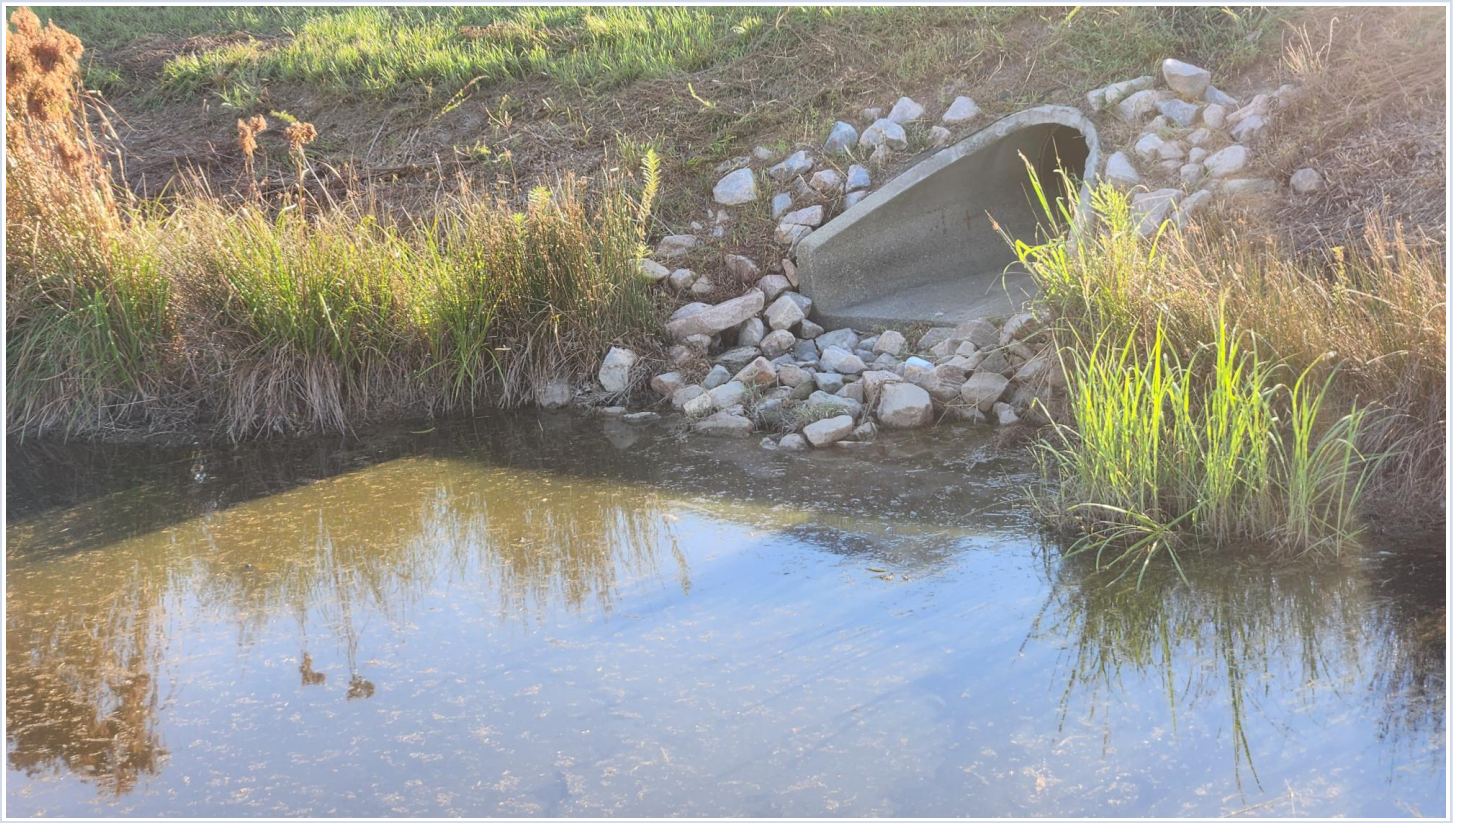
## FRAME 01 · STORMWATER CONTROL MEASURE — OUTFALL

Reinforced concrete outfall pipe with riprap stone apron discharging to permitted stormwater pond. Riprap coverage extends approximately eight feet from pipe outlet; some displacement of smaller stones toward the downstream edge is visible. Grass cover along the pond bank is established. Water level at capture sits within the normal operating range for the pond. Sediment accumulation at the base of the riprap is minor and consistent with routine seasonal conditions. No debris blocking the outlet.

This frame provides a dated overhead-adjacent record of one stormwater control measure outfall on the date of flight. It sits alongside — never in place of — the annual professional stormwater inspection required for permitted SCMs in North Carolina (NCDEQ requires certified inspection annually with reports due 30 June). MW AIRLIFT does not perform the engineering inspection; we produce the visual record the engineer, the reserve analyst, the board, and the carrier can all work from.

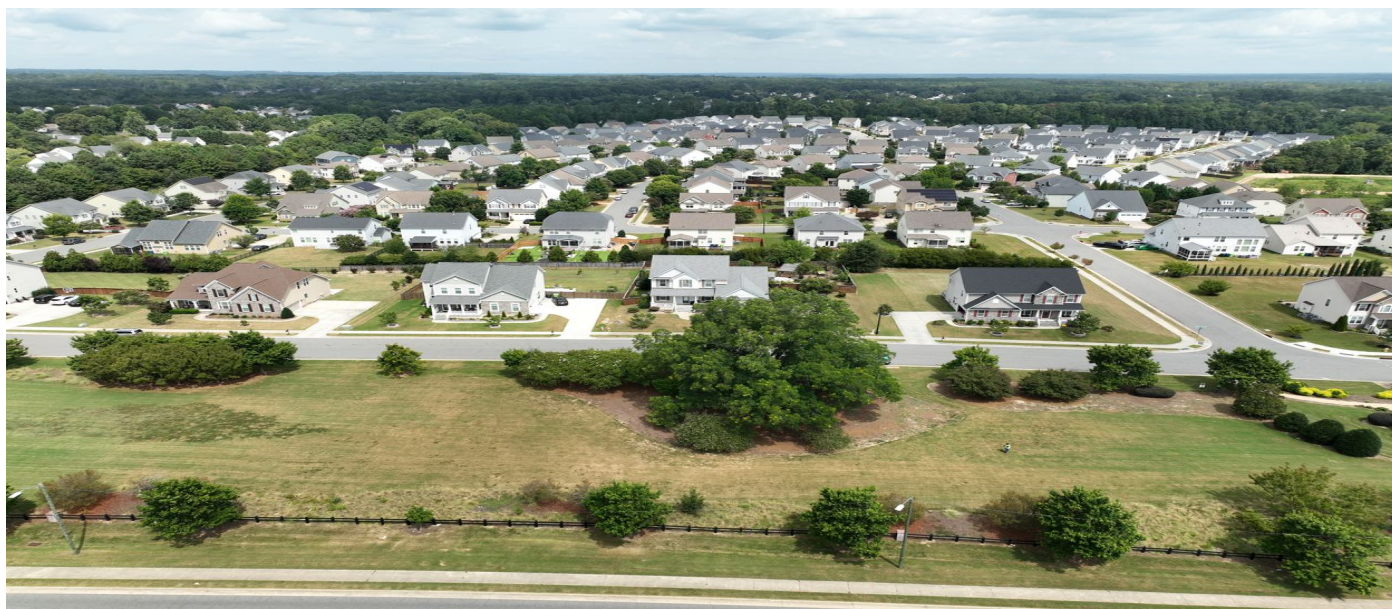
| LOCATION | OBSERVATION | SEVERITY |
|---|---|---|
| <b>Community context</b> | Adjoining streets, lots and the wooded perimeter recorded as an orienting frame for the common areas (Fig. 1) | <b>LOW</b> |

Fig. 1 — Community context on the date of flight. The common open area in the foreground, the streets and lots it serves behind it, and the wooded perimeter — one orienting frame before any detail.

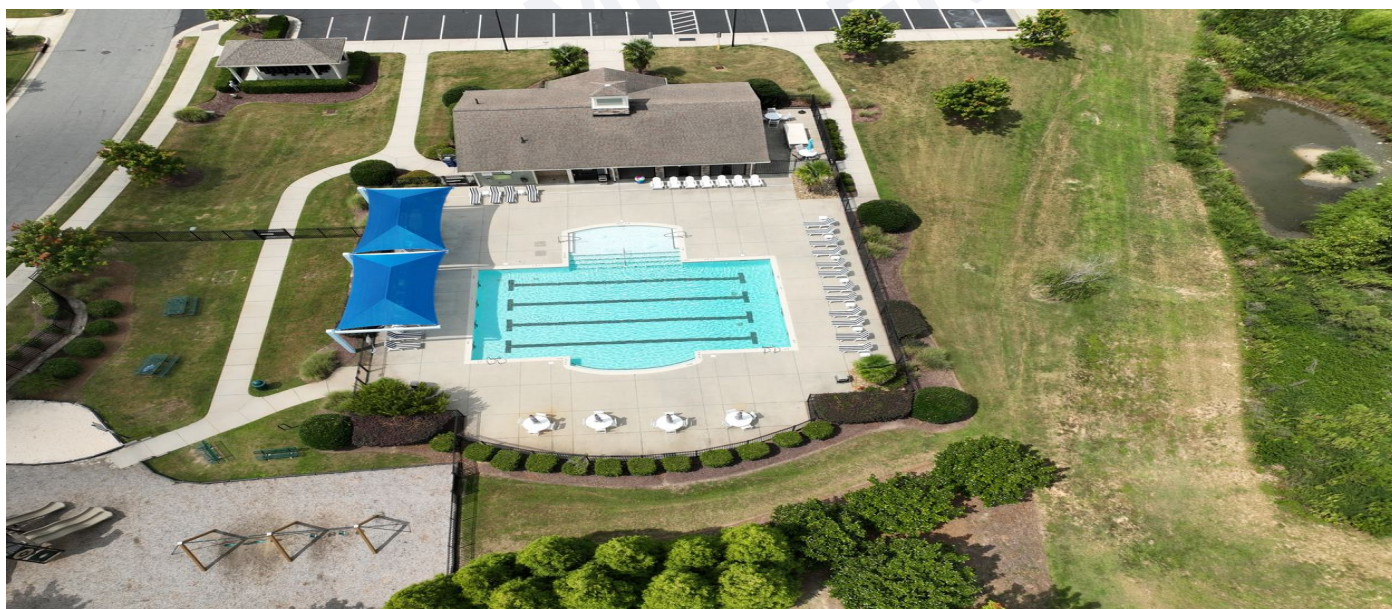
| LOCATION | OBSERVATION | SEVERITY |
|---|---|---|
| <b>Amenity building roof</b> | Laminated architectural shingles across every plane. Granule surface intact in the frames captured; no missing, displaced or lifting tabs observed from the air. Ridge and hip caps seated and continuous (Figs. 2–3) | <b>LOW</b> |
| <b>Pool deck and enclosure</b> | Deck surface, coping and lane markings recorded. Perimeter fence continuous with gates closed on the date of flight; shade sails seated and under tension (Figs. 2–3) | <b>LOW</b> |
| <b>Playground and site furniture</b> | Play structure, swings and safety surfacing recorded in place; tables, benches and umbrellas as found (Figs. 2–3) | <b>LOW</b> |

Fig. 2 — Amenity center from above. Clubhouse roof, pool and deck, shade sails, lounge furniture, playground and the parking that serves them, with the stormwater feature at the right edge.

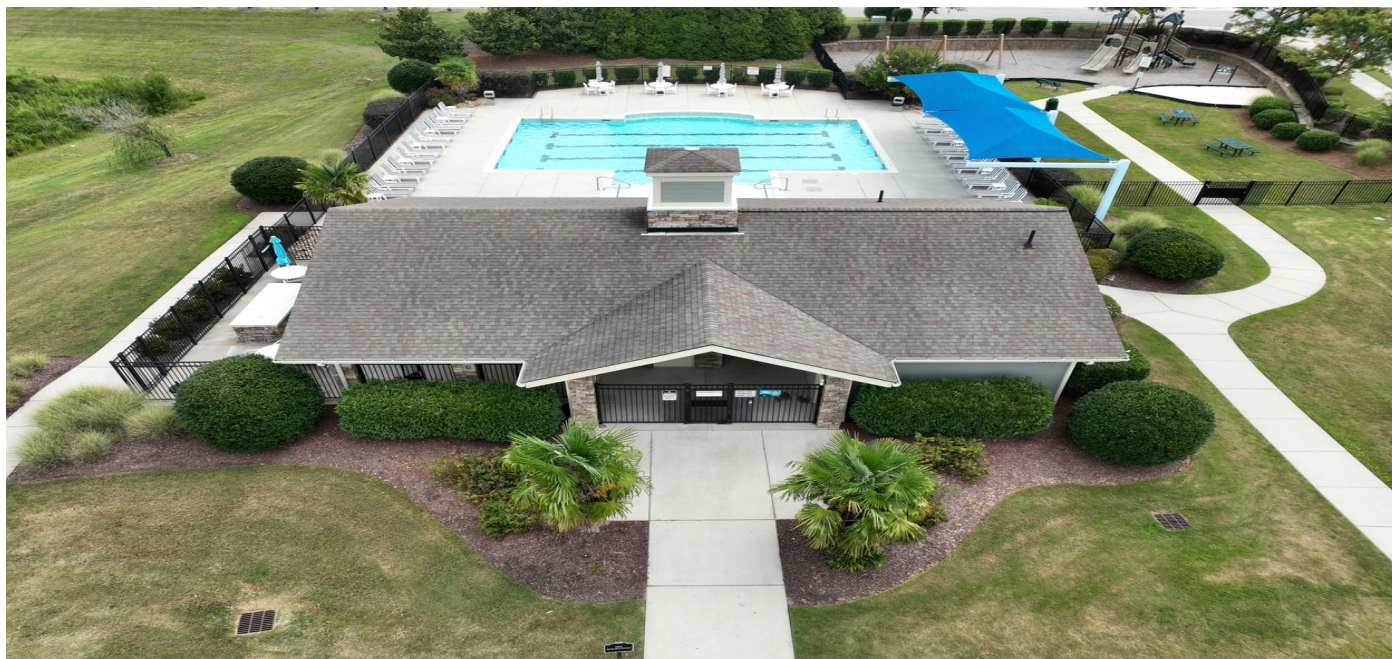
Fig. 3 — Amenity building at closer range. Roof planes, ridge line, the chimney and cupola, gutter line, pool enclosure and gates, and the walkway approach.

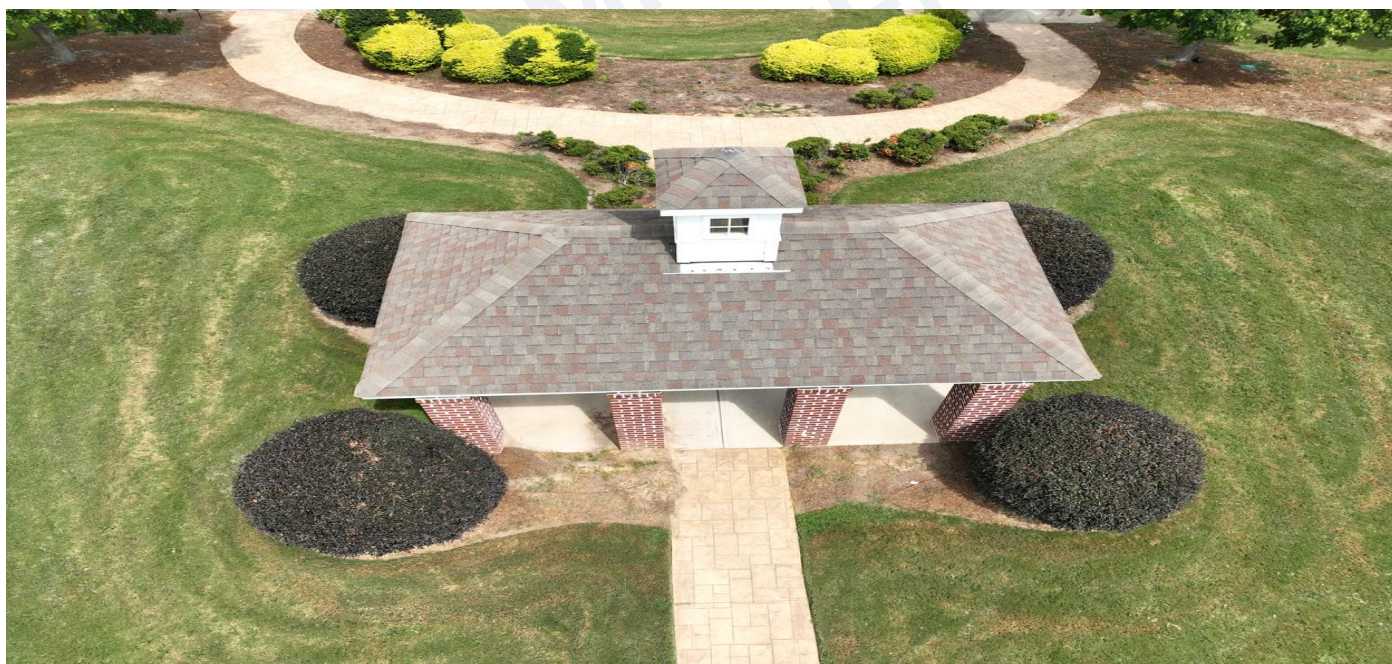
| LOCATION | OBSERVATION | SEVERITY |
|---|---|---|
| <b>Pavilion roof and structure</b> | All planes, hips and the cupola recorded from directly overhead and at elevation. Shingle courses undisturbed; brick piers and open bays recorded as found (Figs. 4–5) | <b>LOW</b> |
| <b>Walkways, drives and parking</b> | Walkway surface, joints and drive approach recorded; parking surface and striping recorded with no ponding visible on the date of flight (Figs. 1–2, 4) | <b>LOW</b> |

Fig. 4 — Picnic pavilion from directly overhead. Every plane, hip and the cupola in one frame — the view a ladder cannot give — with the walkway and bed edging around it.

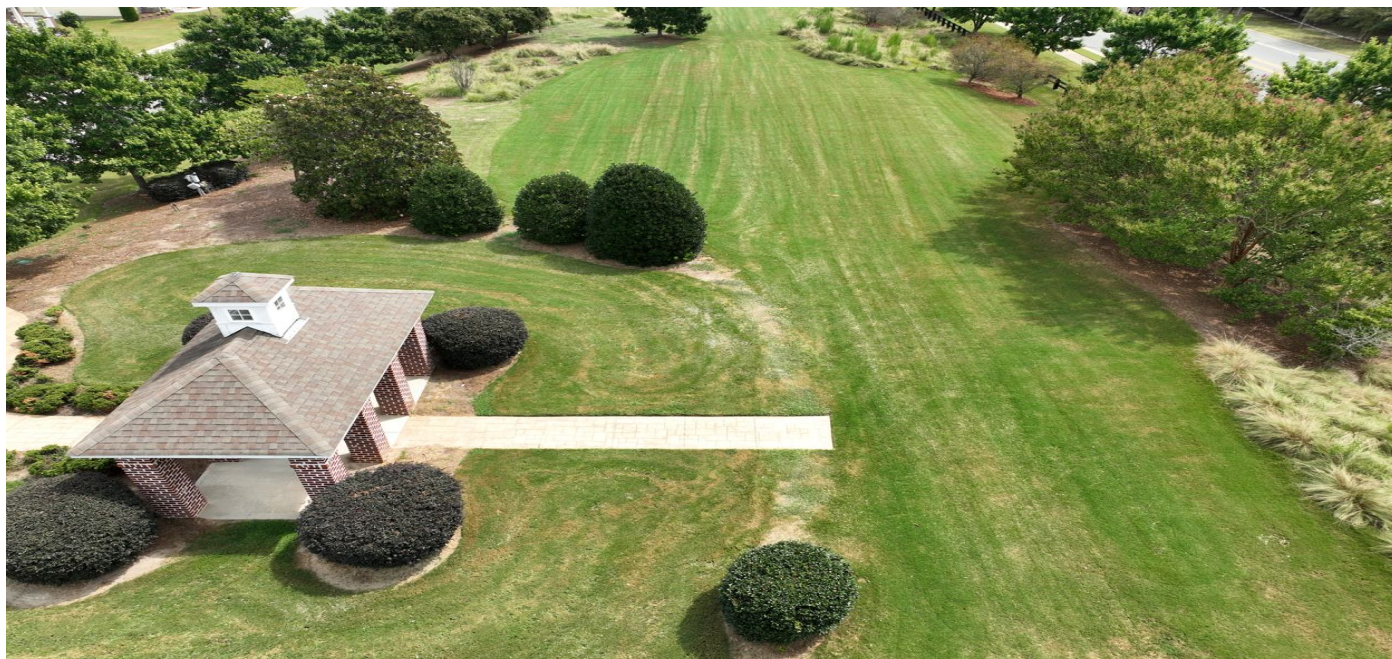
Fig. 5 — Pavilion at elevation with the common lawn behind it. Roof, brick piers and open bays as found, and the walkway running out into the maintained area.

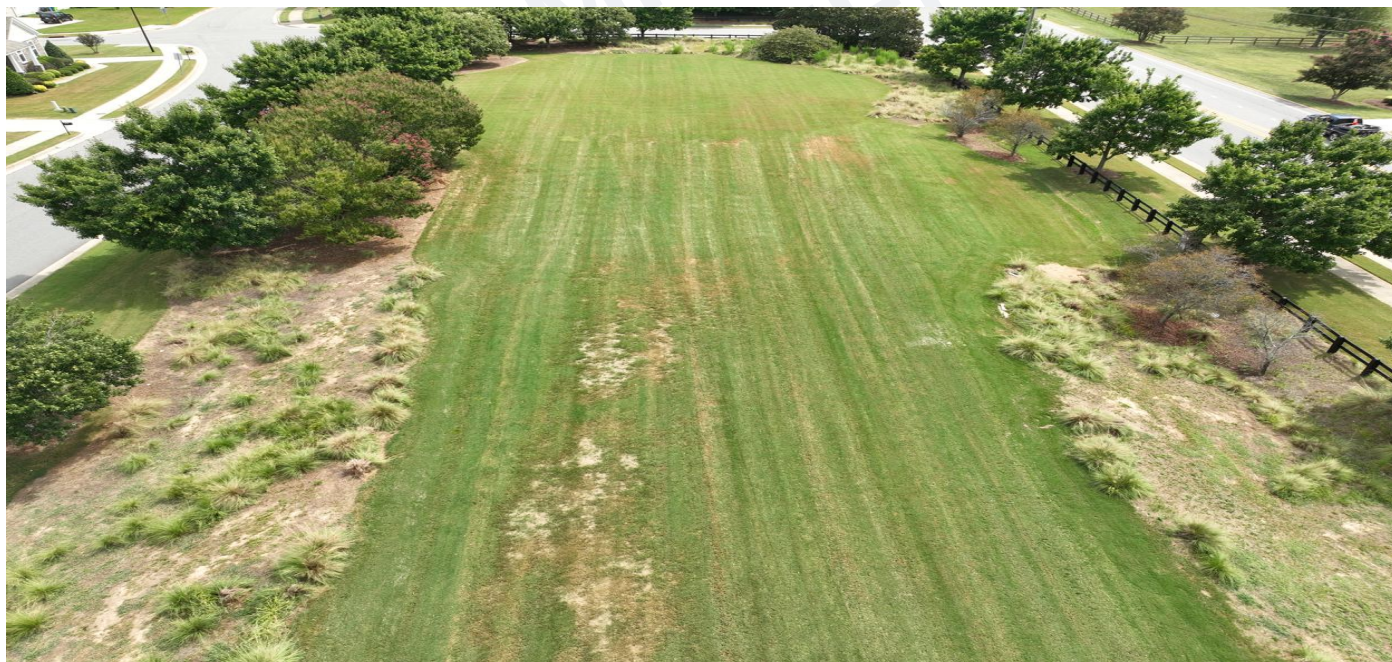
| LOCATION | OBSERVATION | SEVERITY |
|---|---|---|
| <b>Common turf</b> | Maintained turf across the central common area with bare and thinning patches recurring in the same locations, and established ornamental edge planting (Figs. 5–6) | <b>MEDIUM</b> |

Fig. 6 — Common turf. Bare and thinning patches across the central maintained area and the ornamental edge planting on both sides, dated for comparison against the next visit.

Three items warrant the next look. The turf patches recur in the same locations and will either recover or spread. The forebay sediment and basin vegetation are the kind of change a board is asked to fund and cannot easily evidence from the ground. And the work area should be documented again at completion, while the erosion control is still in place and before the surface is covered.

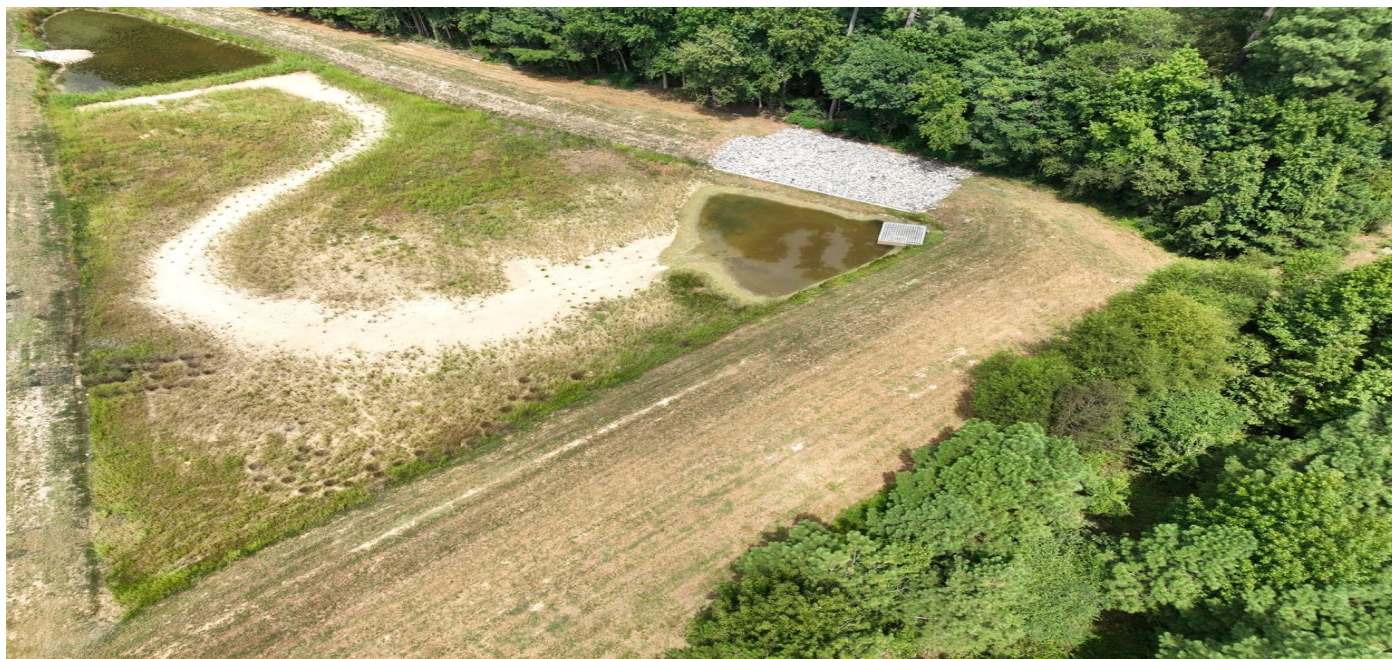
| LOCATION | OBSERVATION | SEVERITY |
|---|---|---|
| <b>Stormwater control measures</b> | Two connected basins recorded. Sediment accumulation and established vegetation across the forebay; the lower basin holding water with the outlet structure clear and the riprap outfall in place (Fig. 7) | <b>MEDIUM</b> |

Fig. 7 — Stormwater control measures. Sediment accumulation and established vegetation across the forebay, the lower basin holding water, the outlet structure clear and the riprap outfall in place.

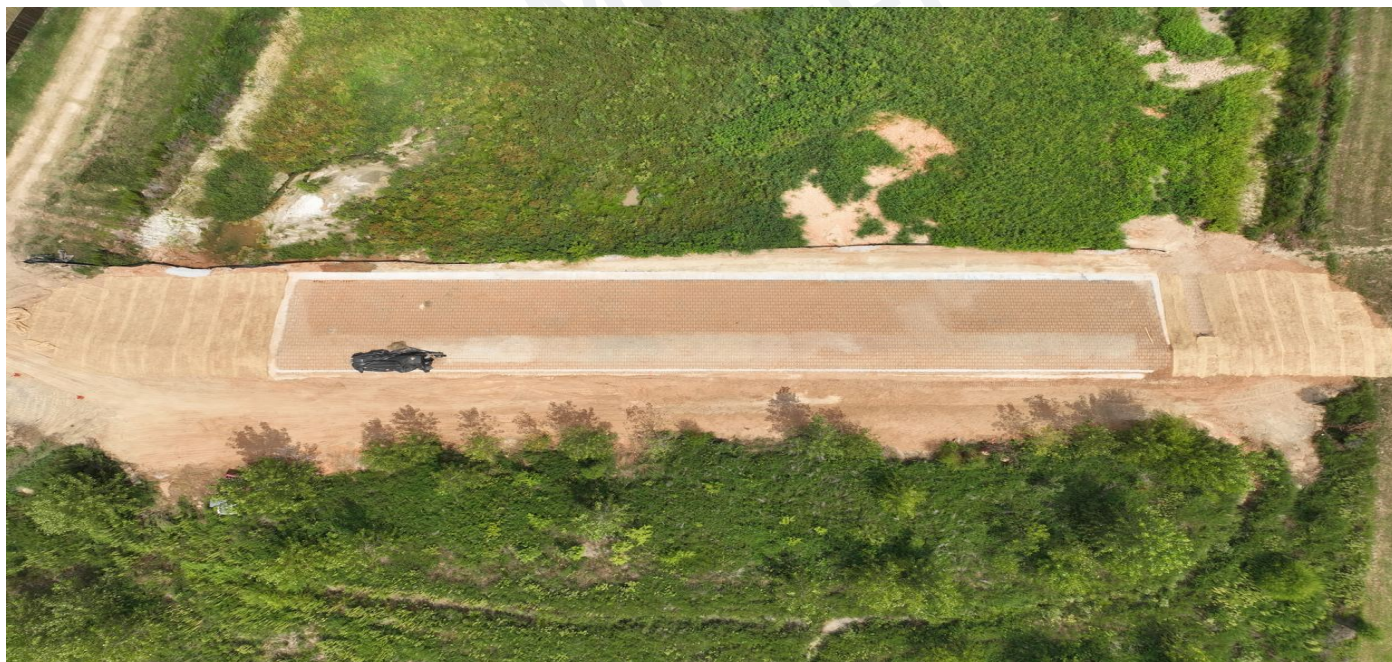
| LOCATION | OBSERVATION | SEVERITY |
|---|---|---|
| <b>Active work area</b> | Permeable paver pad placed with the perimeter curb formed. Silt fence in place along the wooded edge; disturbed soil and stockpiled material adjacent, with straw stabilization begun on the graded slope (Fig. 8) | <b>MEDIUM</b> |

Fig. 8 — Active work area. Permeable paver pad placed with the perimeter curb formed, silt fence along the wooded edge, and straw stabilization begun on the graded slope.
